High Strain Rate Signatures of Additively Manufactured High Entropy Alloys

Presenter: Alec Mangan¹ PI: Dan Thoma¹

Contributions by: V.K. Euser², D.R. Jones², D.T. Martinez², A.K. Agrawal¹, S.J. Fensin² 1: University of Wisconsin-Madison 2: Los Alamos National Laboratory

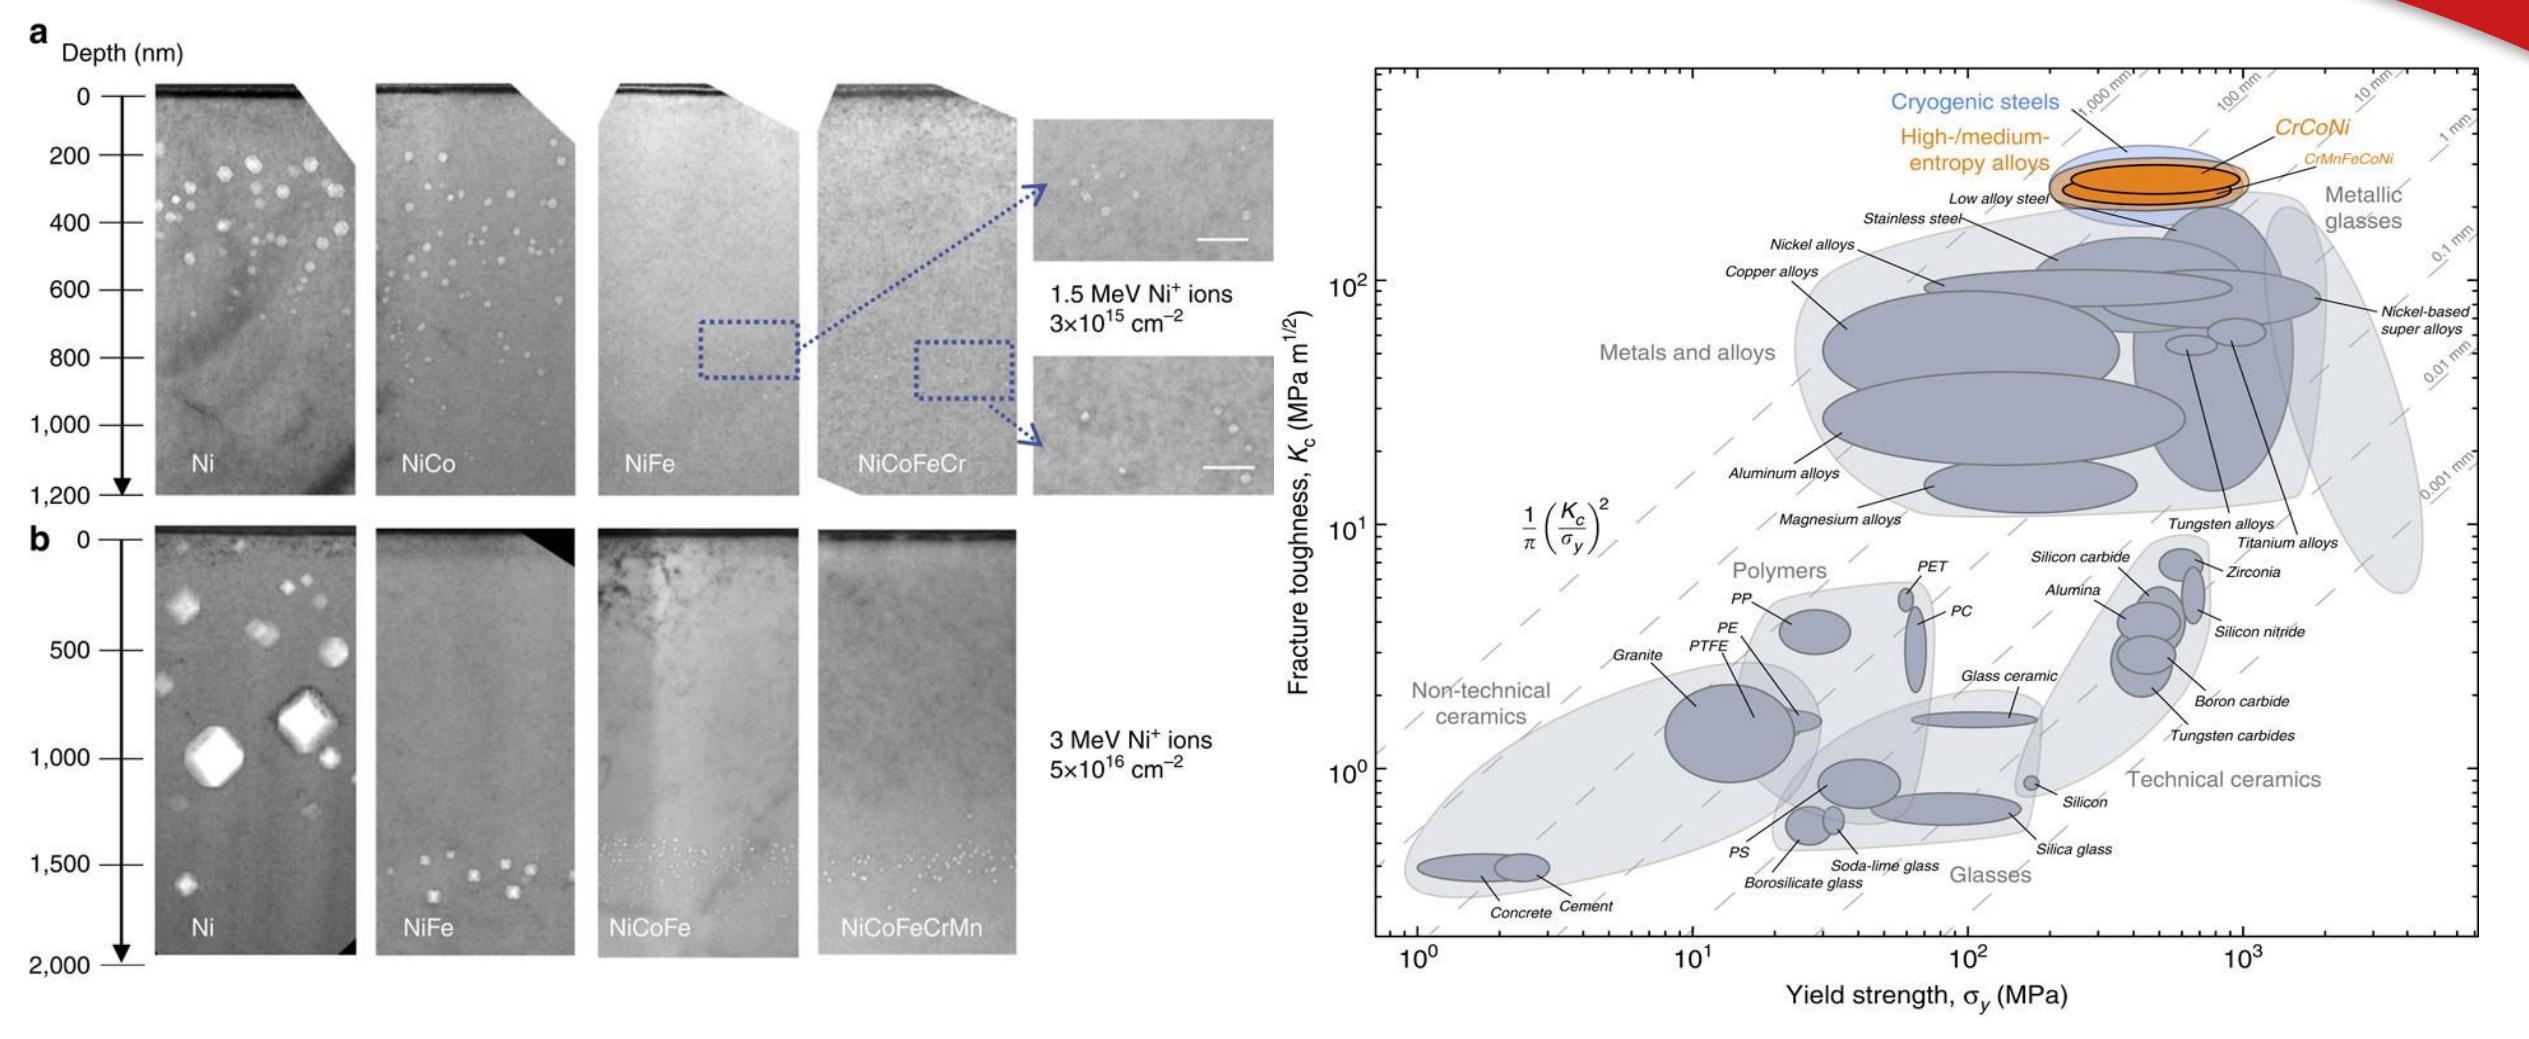
CoCrFeMnNi High Entropy Alloy (HEA)

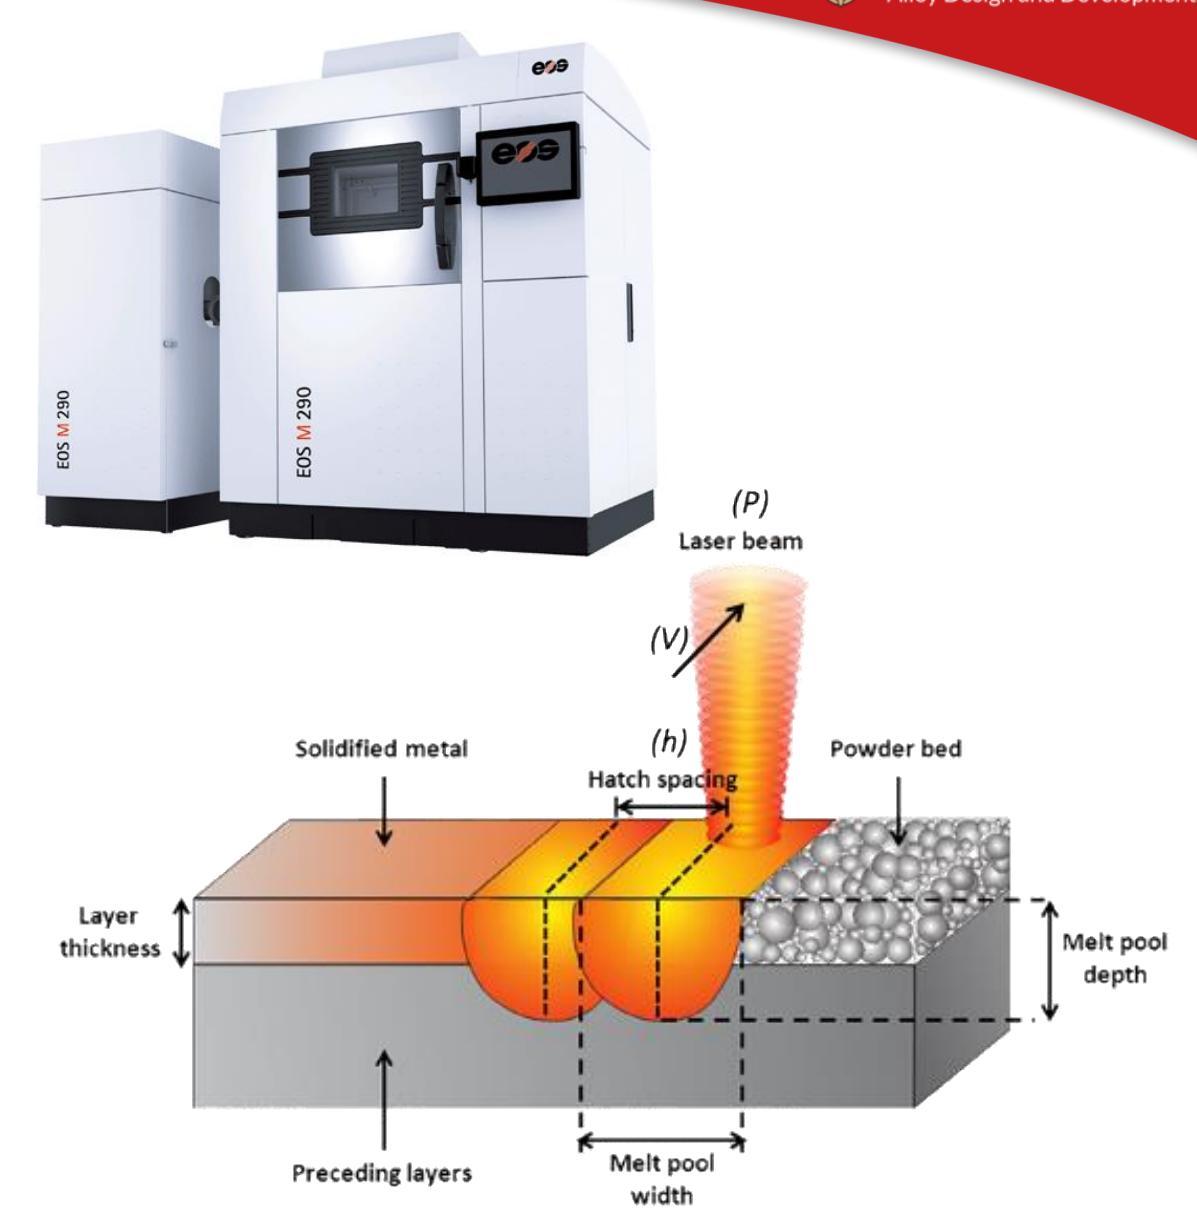
Laser Powder Bed Fusion (LPBF)

- EOS M290 has over 100 process parameters to control.
- Power (P), Velocity (V), Hatch Spacing (h) control melt pool geometry.
- Fast cooling rate (10⁶ K/s) creates fine microstructure.

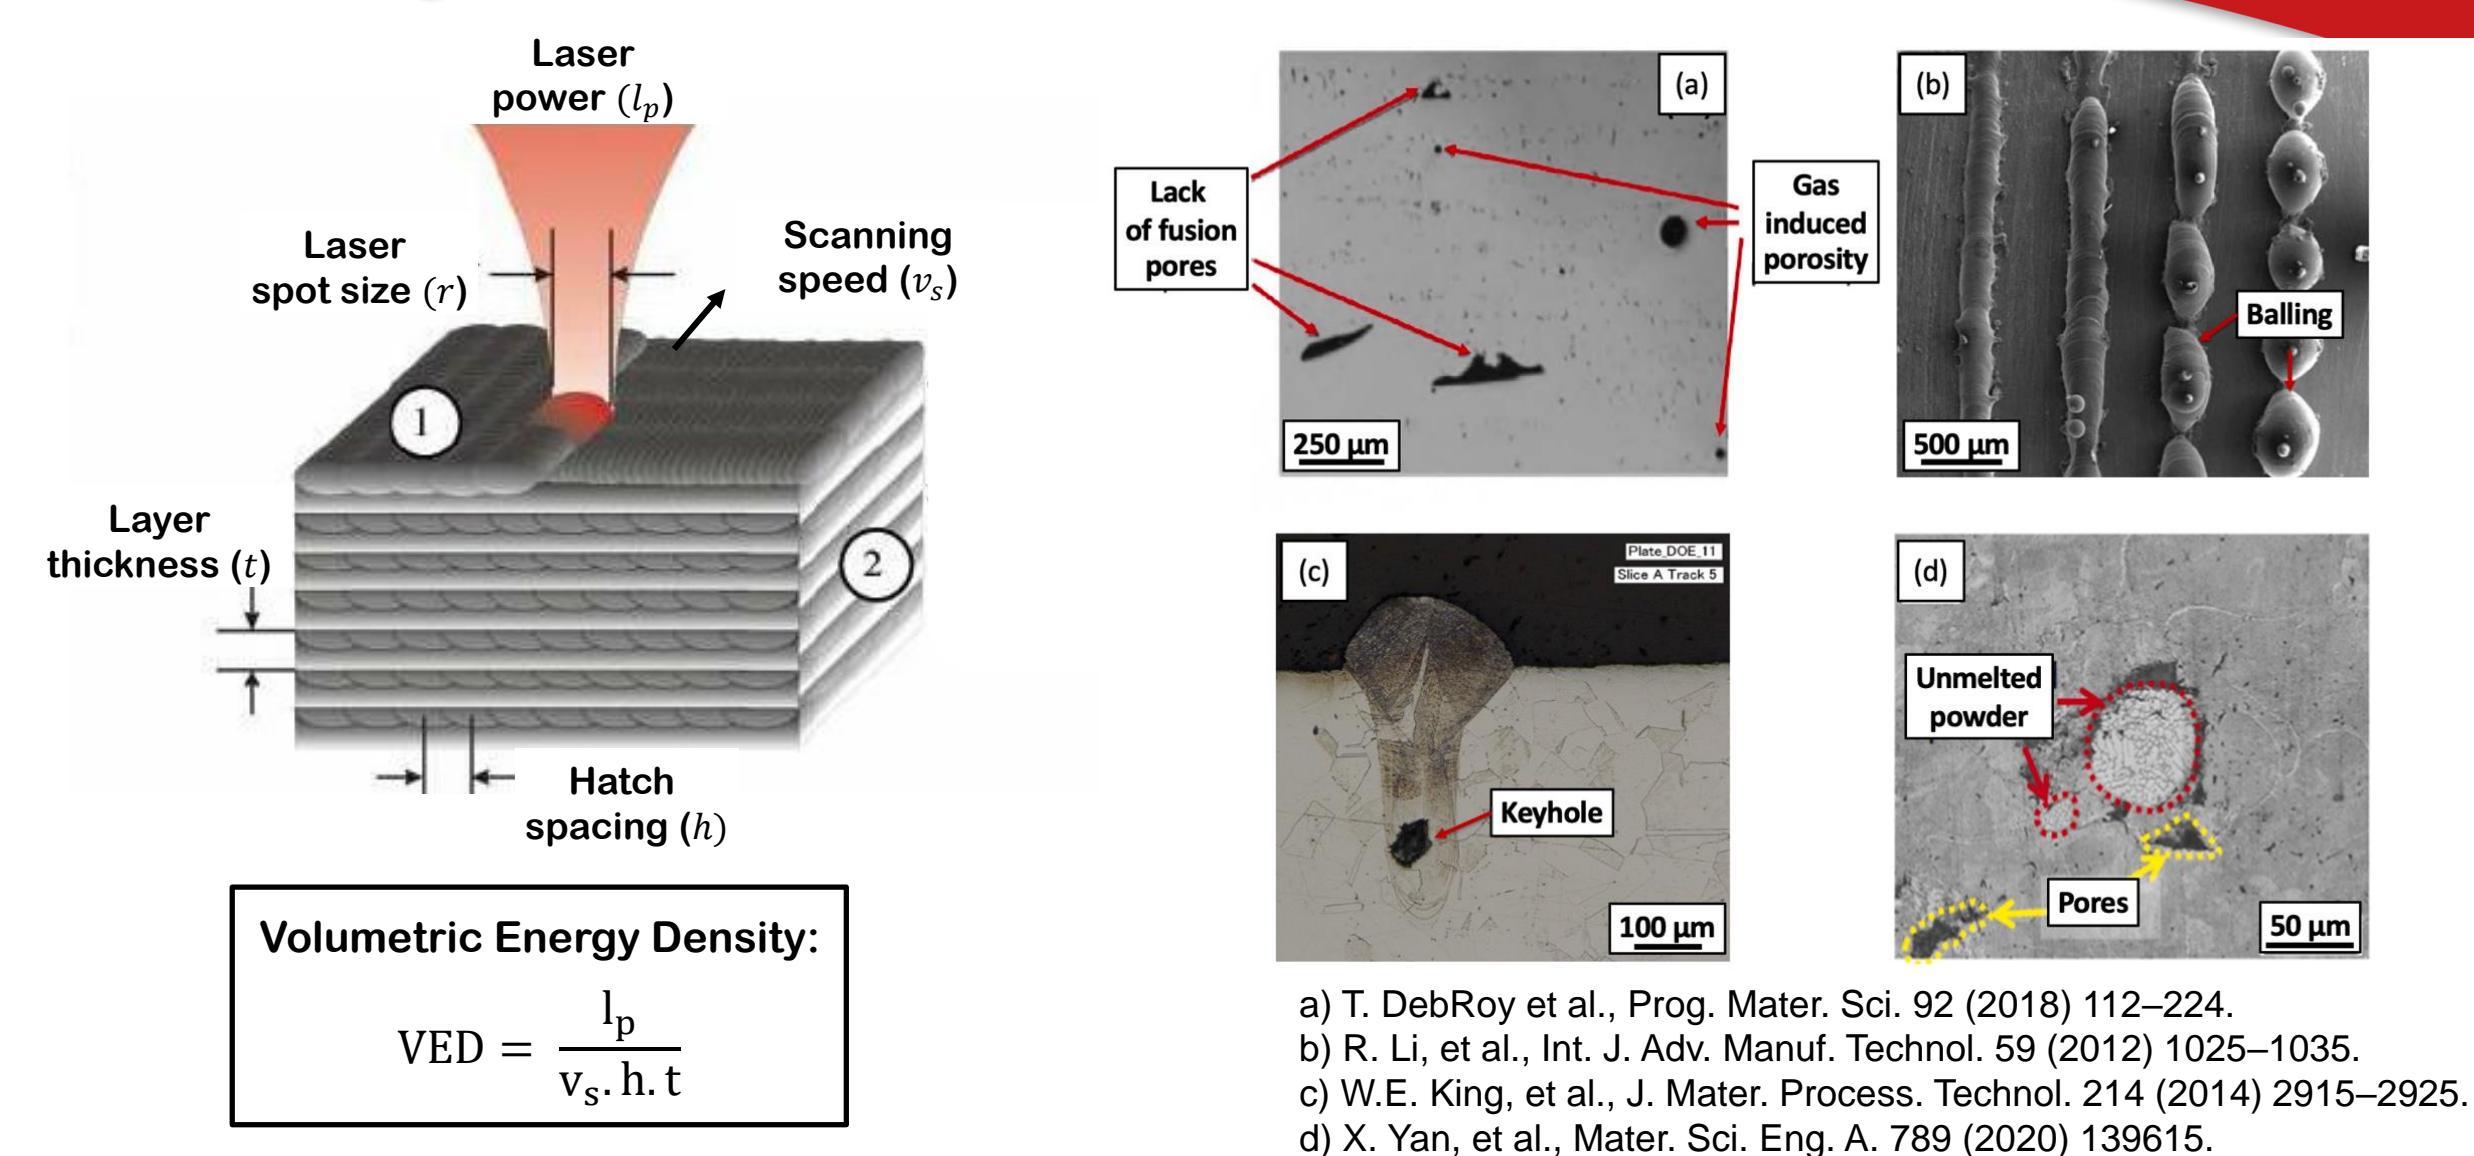
Processing Defects in LPBF

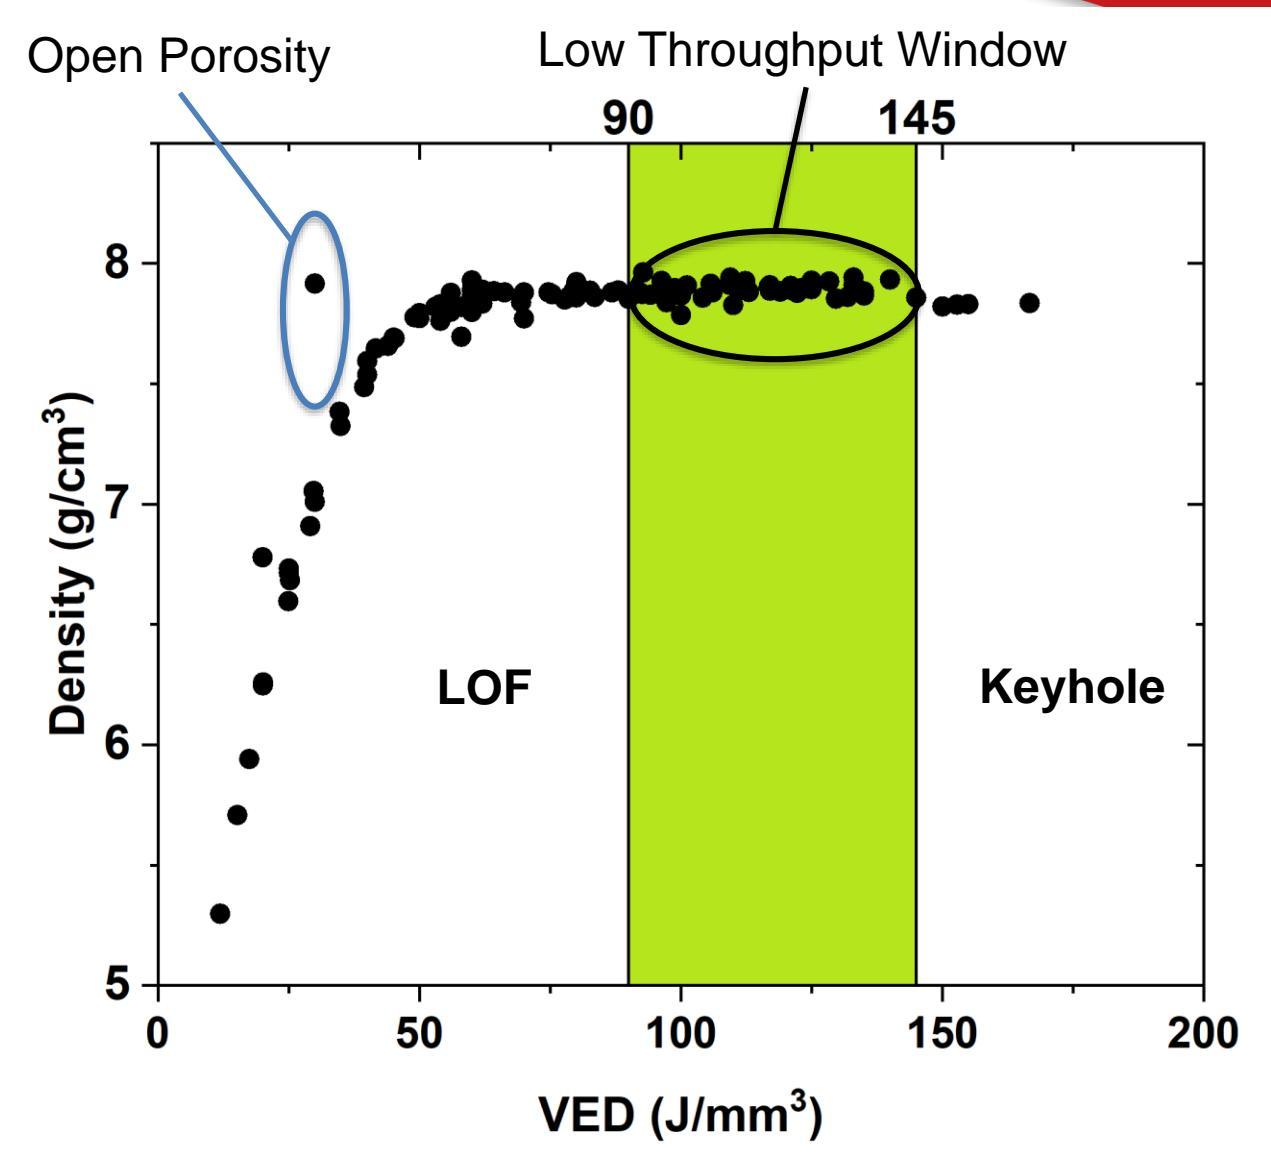
High Throughput Experiments

- 242 processing conditions explored across power, velocity, and hatch spacing
- Density and hardness measured for each condition
- Low throughput processing regime chosen within bounds of highest density and hardness conditions

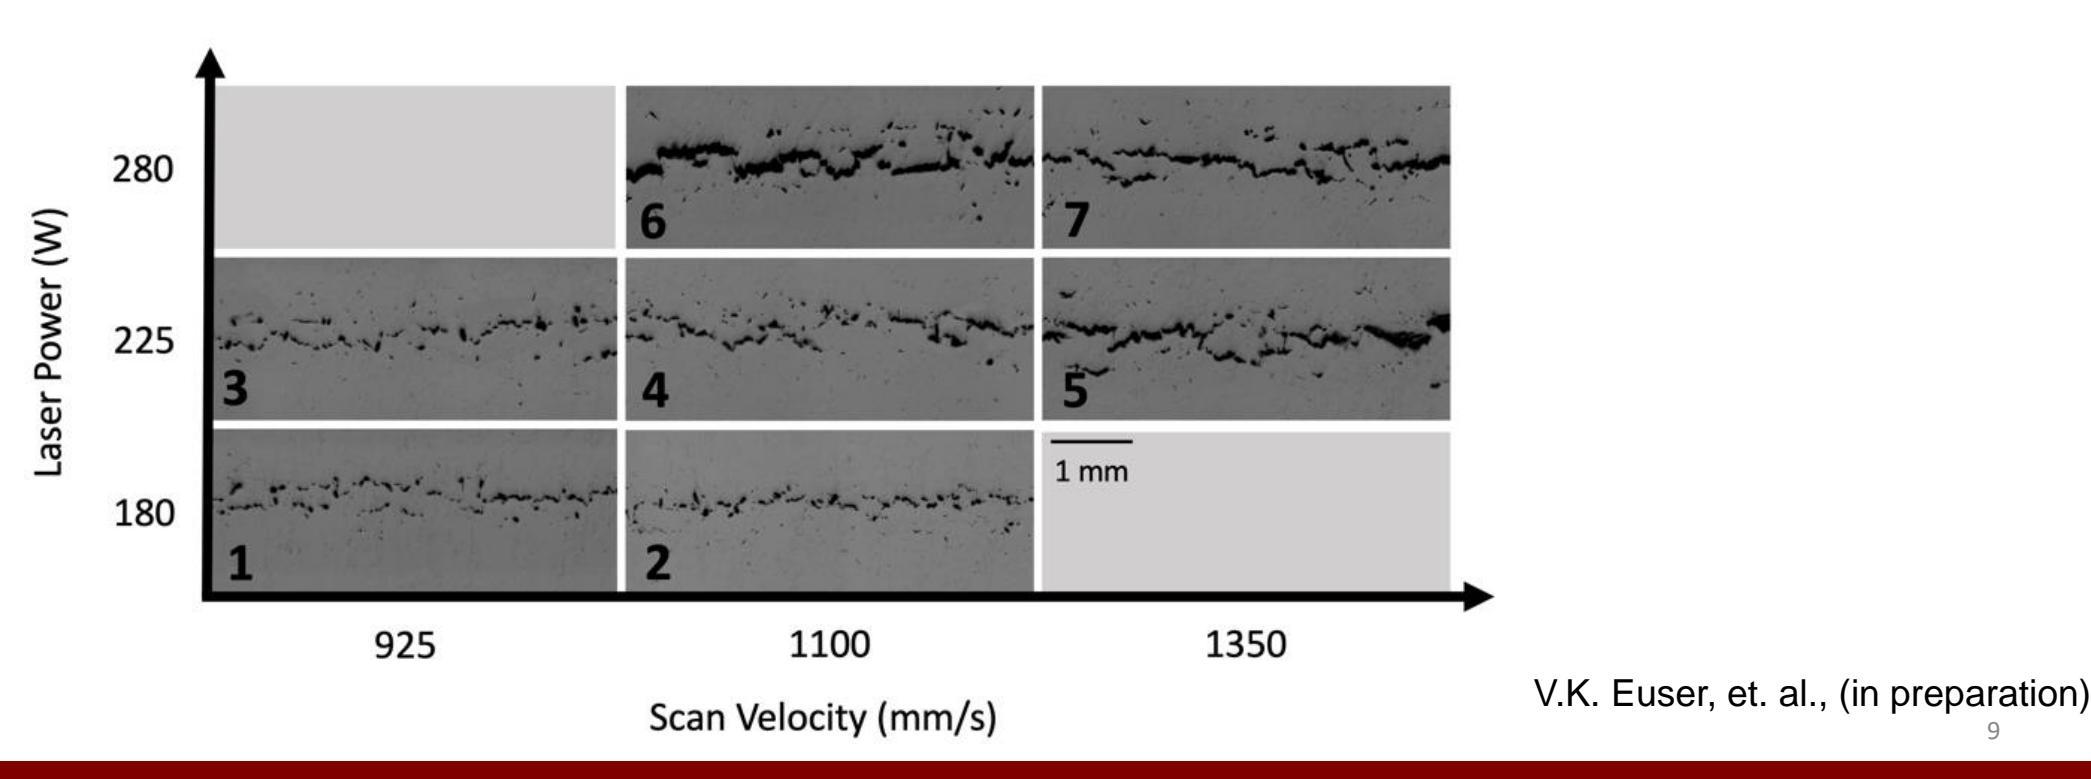
Spall

Occurs when shockwaves create a tensile pulse within a material causing voids to form on a spall plane. Spall strength is the resistance of a material to spall fracture and is measured through soft capture plate impact experiments.

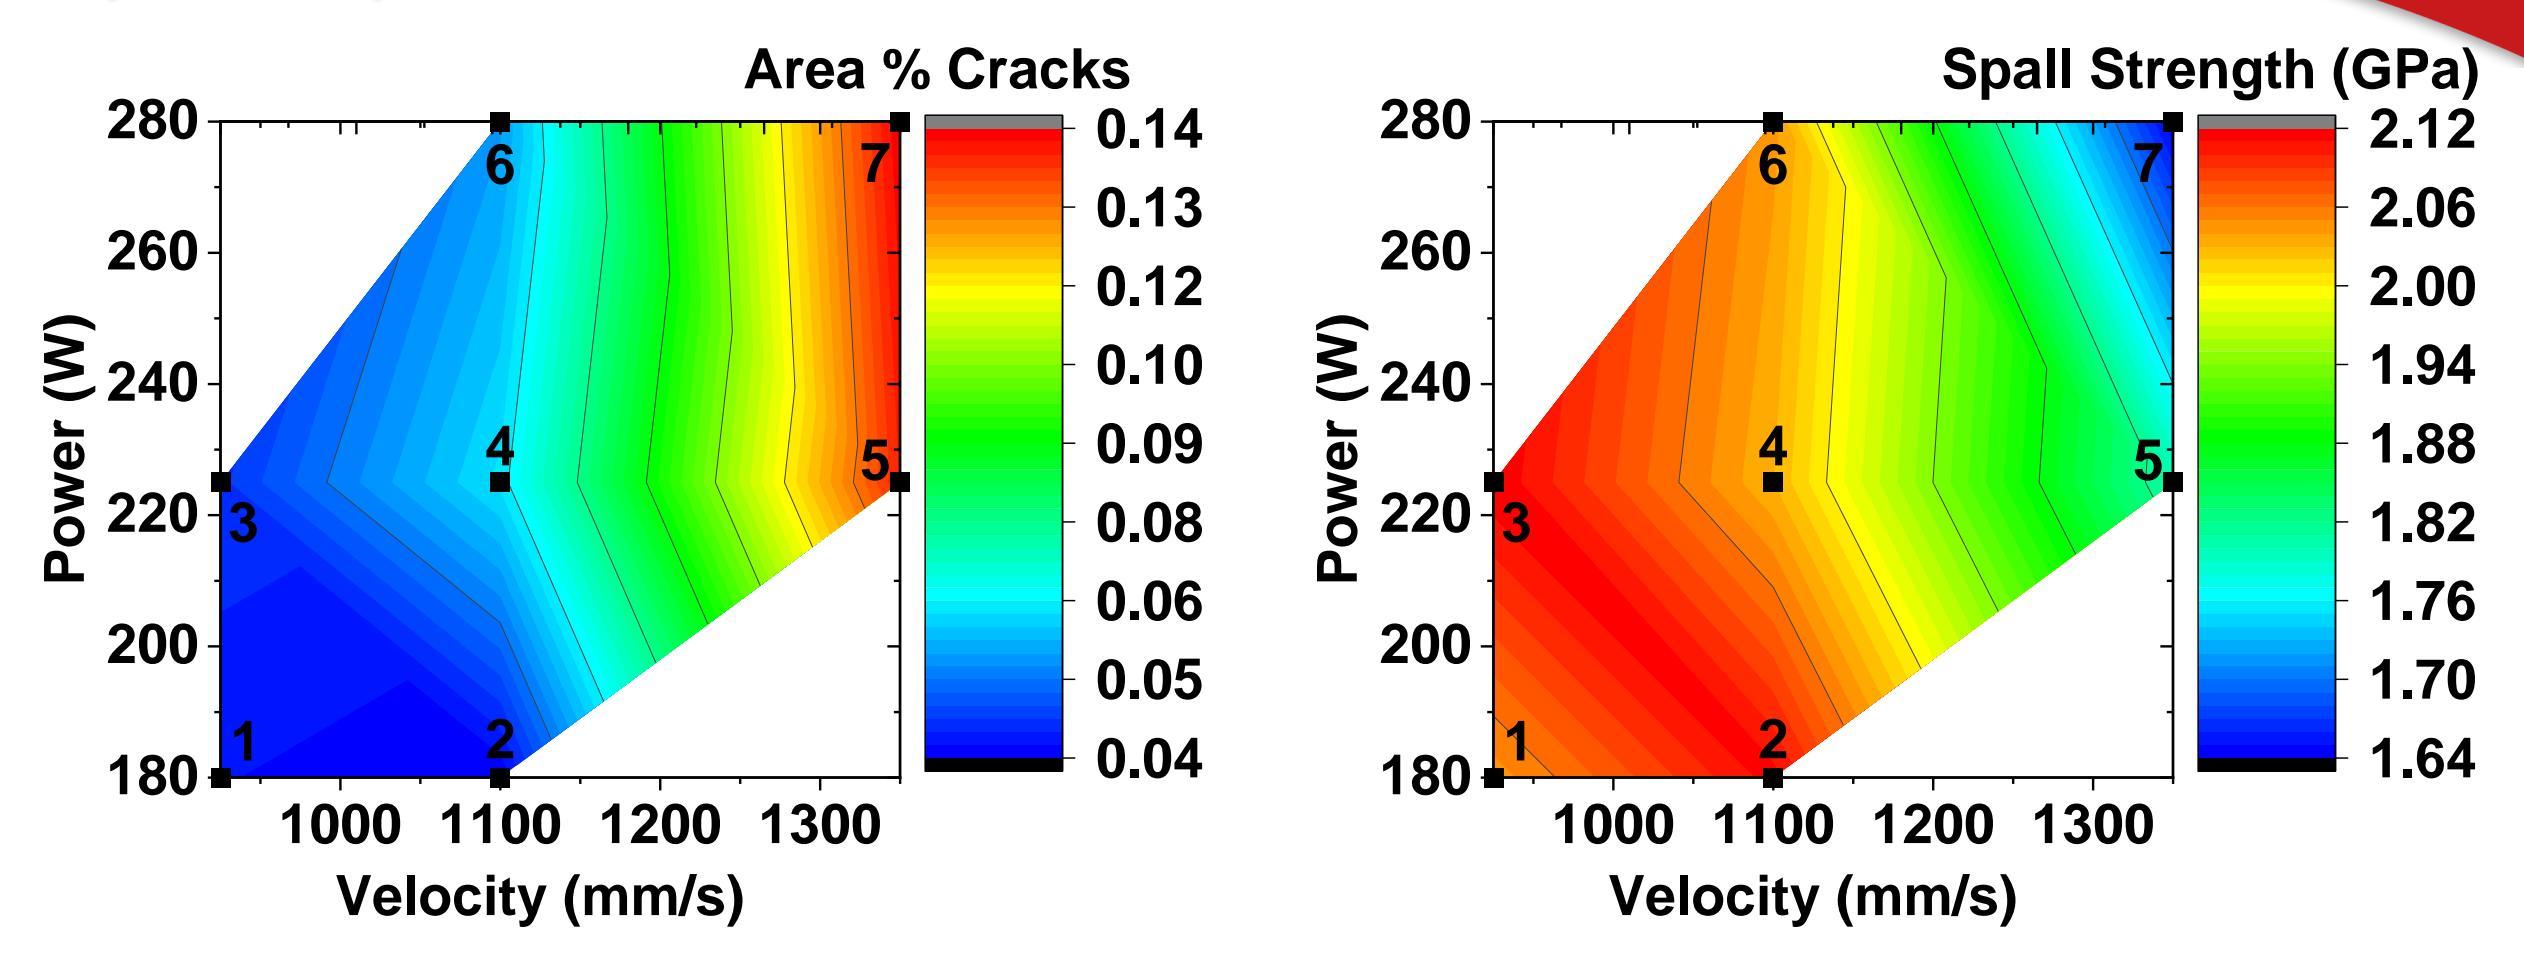
Spall Response

An increase in crack density correlates with a decrease in spall strength

Pre-existing solidification crack density was found to correlate best with spall response

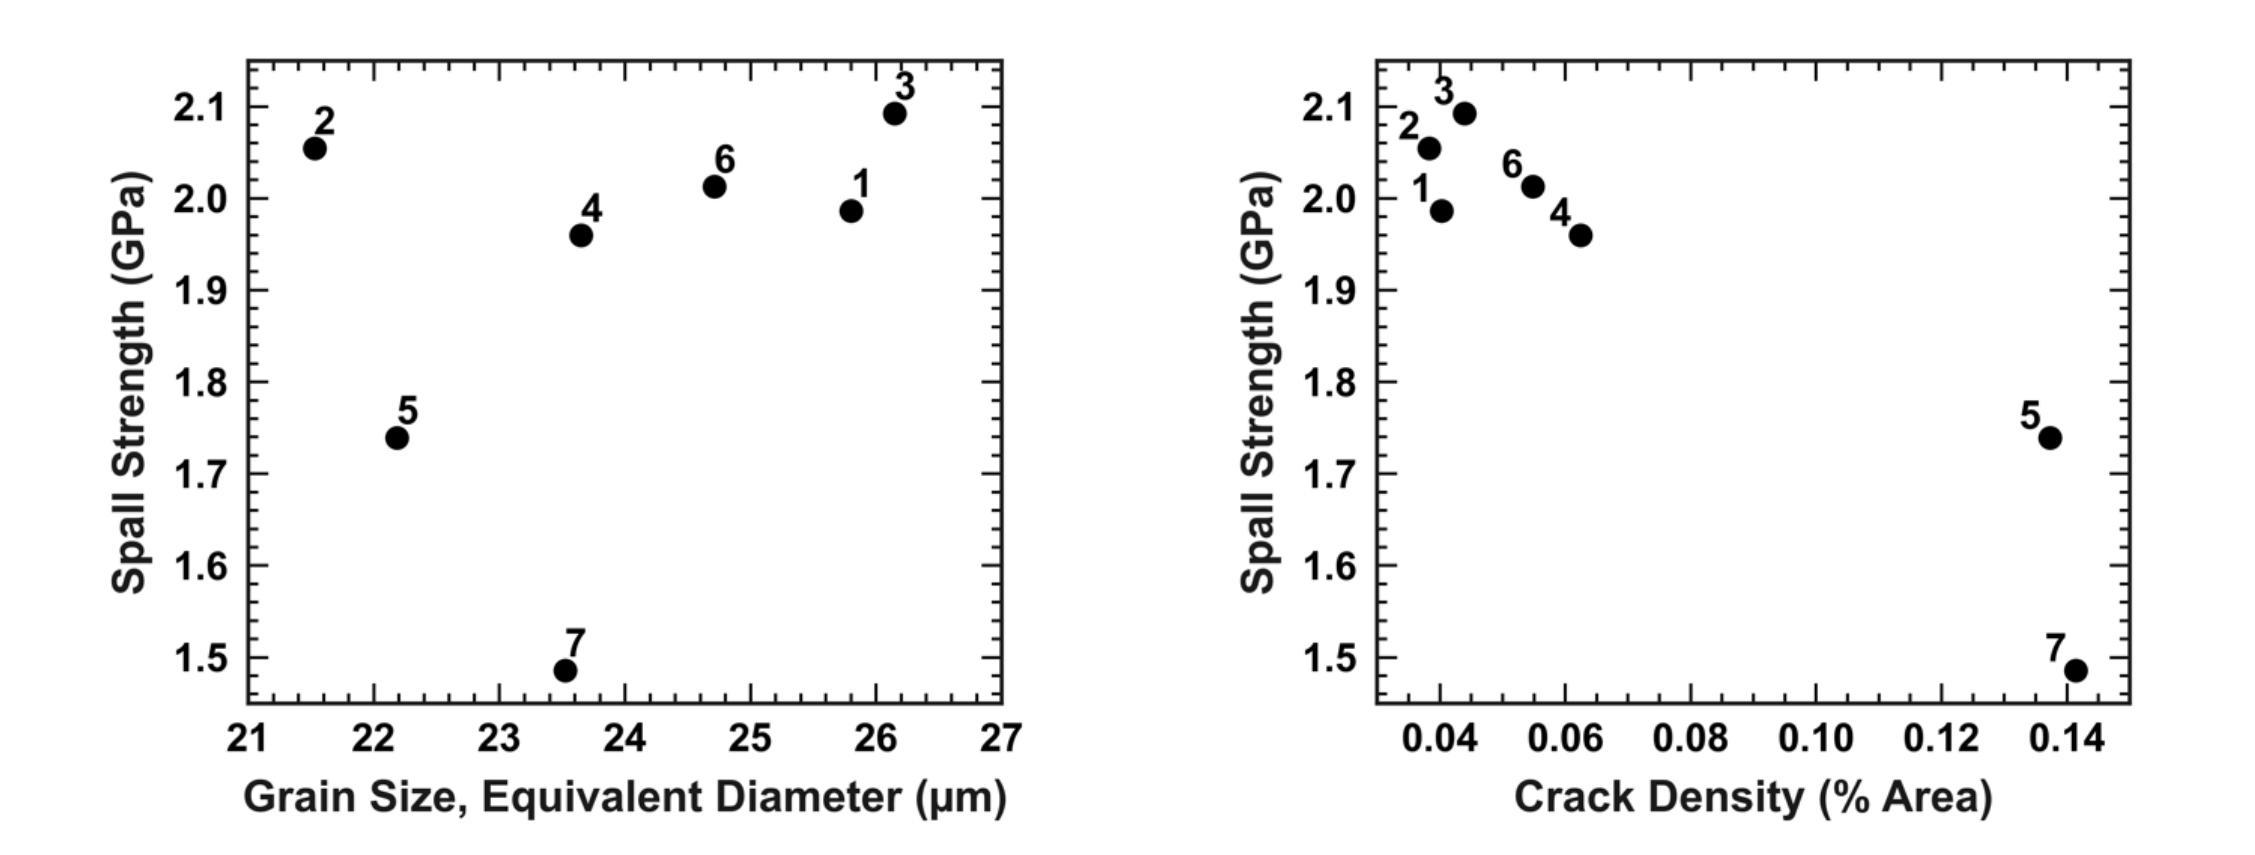
Spall Response

No correlation between grain morphology and spall response

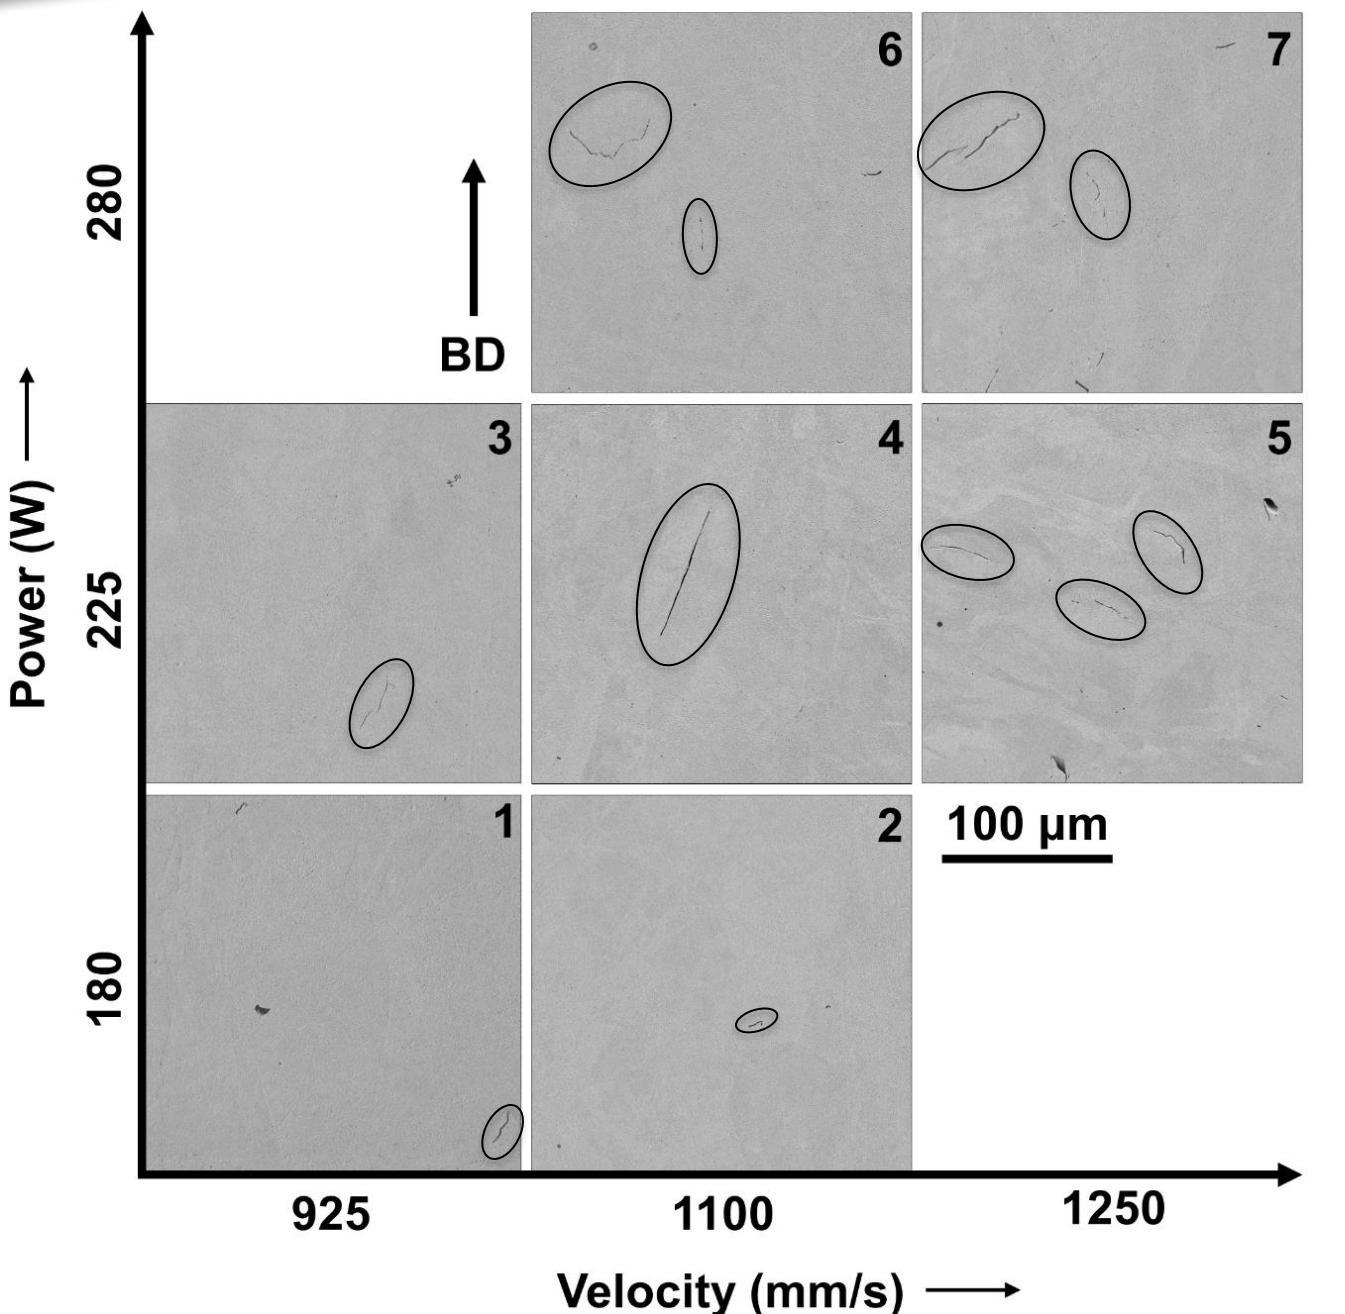
Cracking

- Microcracking was visible across all samples
- Larger and more numerous cracks evident at higher power and velocity
- Cracks averaged 20-25 µm

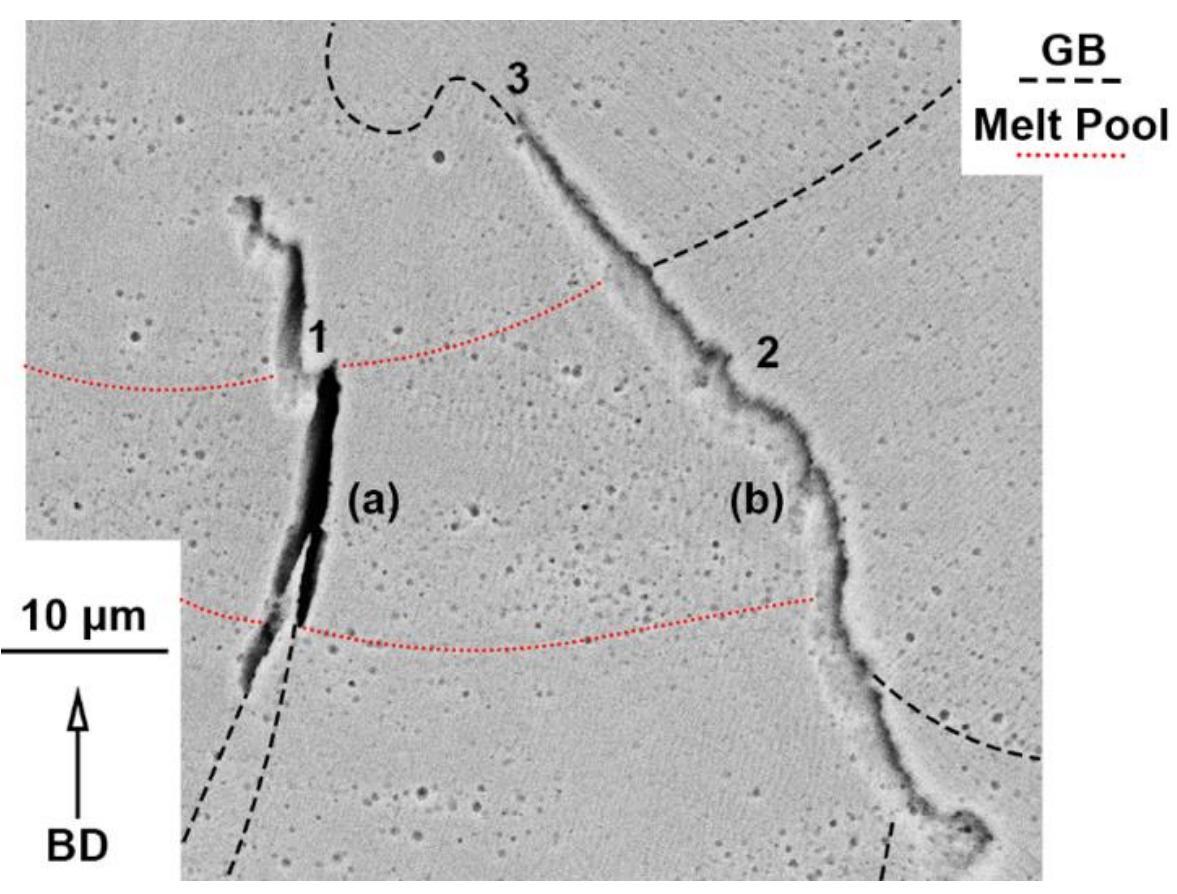
Crack Morphology

A) An intragranular crack

B) An intergranular crack

- Crack follows melt pool boundary
- 2. Dendrites within the fracture surface
- Crack initiation at grain boundary

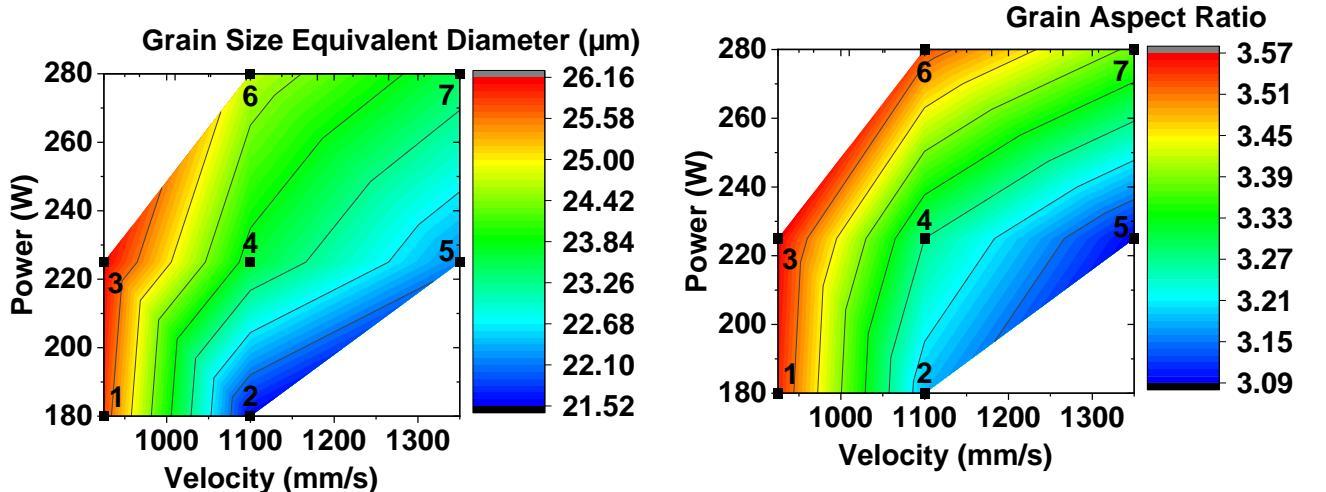
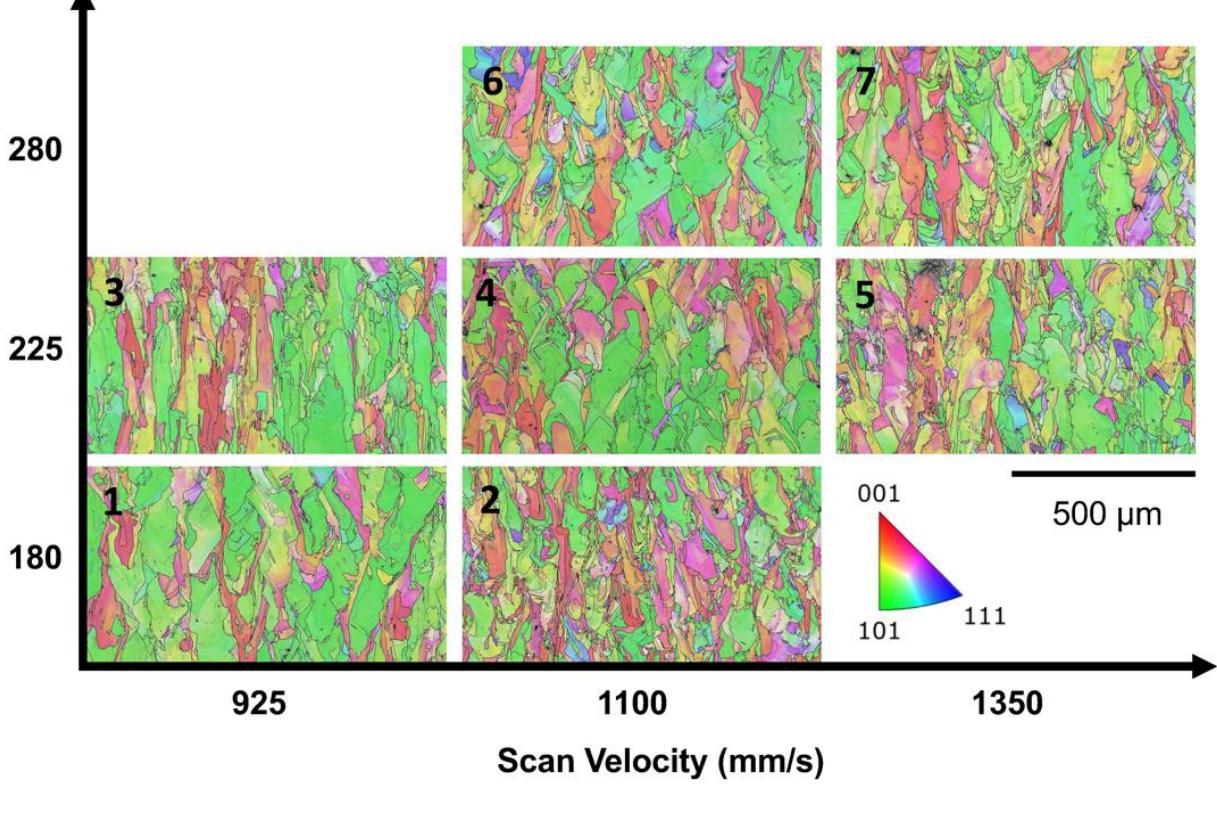
Grain Morphology

• Elongated grains in the build direction consistent with LPBF

Grain size and aspect ratio decrease less than 20% as VED decreases

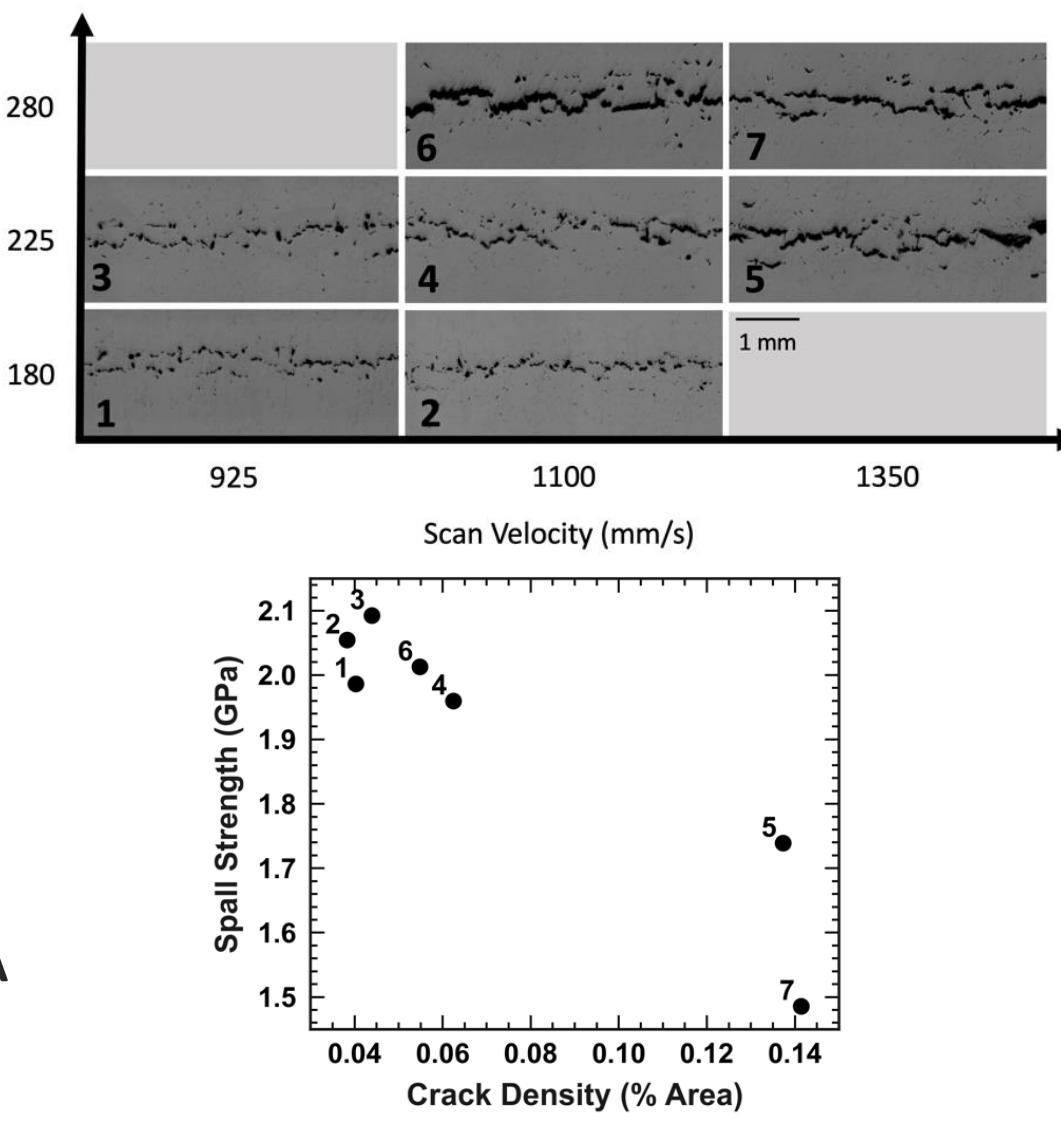
Seven conditions of LPBF HEA were evaluated using high strain rate experiments
